New Insight into the Origins of the Ashdown Forest Centre Barns

Pam Griffiths, *Ashdown Forest Research Group*

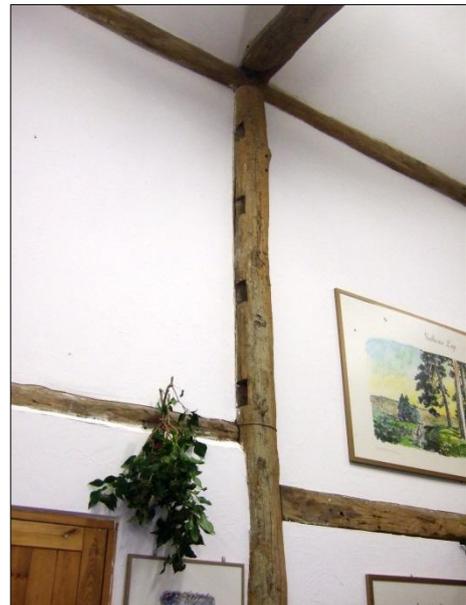
Our initial pride in showing off the barns was dampened somewhat in the Education Barn, as she was clearly underwhelmed by what she found. Mortises carved into beams failed to match up with their opposite numbers, so couldn't have held the expected but absent braces. Weathering on some of the internal posts showed them originally to have been used externally. Roof braces were too small for a structure of this size; some bays had queen posts (pairs of vertical posts linked by a horizontal and which are set on a tie beam as part of the roof truss) while others didn't, and holes in the tie braces weren't being used the way they should have been. Perhaps the feature which caused the most disdain was the use of a timber as an upright support which was cut with 'birdsmouths' - V-shaped notches sunk into an eaves beam to support rafters - something to be expected to be on a horizontal not a vertical feature.

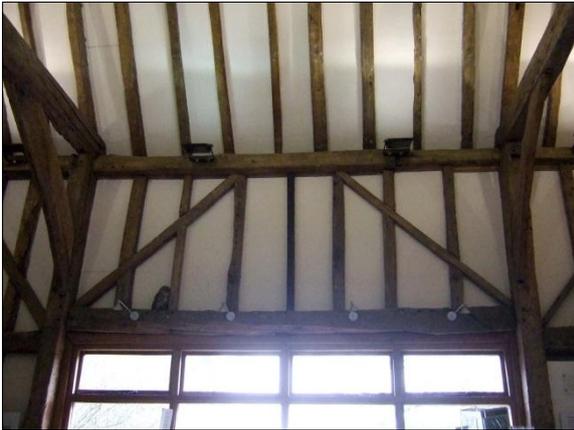
The other two barns provoked a much more positive reaction. The Information Barn is the most likely to be the Sussex barn mentioned by Barbara Willard, its proportions in keeping with Wealden style, according to Dr Hughes. It currently has four bays, but there are signs that the northern end has been tampered with at some time, so there may have been a fifth originally. This would fit the hypothesis that it had been a threshing barn. Such buildings had a pairs of doors on either side of the middle bay to allow the wind to blow the chaff away. The large window opposite the current door has a horizontal beam above, suggesting

this is where the top of the threshing doors were. Mortises set on the 'door' side of the adjacent roof beams would tend to confirm this as it was customary to place roof braces on the door-side of the posts nearest the opening. The northwest corner has a good example of a root stock upright post. Placing the tree-trunk upside-down allows the top to splay out and provide enough material for the complex jointing needed.

Other notable features in this barn are: substantial roof braces, which on the whole fit into mortises carved for them; queen posts in keeping with the rest of the barn, so probably original; and eaves plates (the long horizontal beams where walls and roof meet) which have been scarfed - had a step cut at the end of two separate timbers so that they can be linked together to run the length of a wall. There is no ridge board in the apex of the roof; instead the rafters are pegged together at the top. This, and the fact that the barn also has butt purlins (horizontal, longitudinal beams in the roof) and that these are slightly staggered to spread the load on the rafters, suggest the barn was originally erected sometime between 1650 and 1750. This barn is sizeable, probably belonging originally to a farm of at least 100 acres.

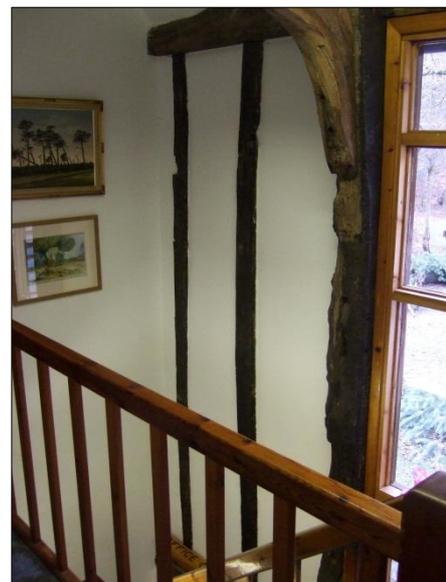
The Administration Barn, adapted considerably to turn it into office space, still shows enough original features to make it likely that this is Barbara Willard's Kentish barn. Dr Hughes identified it as of at least Eastern Wealden origin, probably from Kent, referencing the close-studding beside the stairs, which runs the entire height of the wall. In the roof space there is wind-bracing, a technique designed to stop the roof twisting out of true. This, along with other features, like the fact that the apex has been pegged, suggests that the building dates from 1650 and 1700, maybe up to 50 years older than the Information Barn.

In a number of places, original braces are still in evidence, fitting snugly into the mortises made for them over 300 years ago. However, some of these would have blocked access, or cut across an office desk in the barn's current incarnation, so in places they have been replaced by knee braces, cut from timber which has grown naturally into a right-angle. Another notable feature in this barn is the use of clasped purlins - longitudinal beams in the roof fitted under rafters and over the collar beam between them. Beams have been scarfed here too, and the ties crossing the space at eaves level have been prepared to fit solid upright timbers. Here, though, these uprights no longer exist, leaving at least one tie beam looking as if it balances rather precariously on a baulk of wood bolted to the wall. This barn has four, possibly five bays, and probably also belonged to a sizeable farm of around 100 acres.
